ARTICULATED MOBILE CRANE

Annual Report

Make		Franna		
Model		MAC 25		
Serial Number		25912		
Plant Number Year of Manufacture Design Registration Number Plant Registration Road Registration Max Load Number of Axles Lower Hours		114		
		2013 Q16799		
		756 TGR		
		25000		
		2		
		4926		
		Kilometers		25122
Country where	assessed	Australia	State	NSW
Operators Man	ual in English	Yes	Log Book	Yes
Crane Safety M	anual	No		
Assessed By	Troy Kiem		Company	A1 Crane Inspections
Reg. No.	NSW1082		Address	P O Box 414 KURRI KURRI
Phone	0425 384 09	1	State	NSW
Email	a1craneinspe	ections@gmail.com	Postcode	2327
Initital Inspection	on Date	04/09/2017	Issued Date	07/09/2017
Re-Inspection	Date	06/09/2017	Expiry Date	06/09/2018
Conforms to	Checklist	Yes

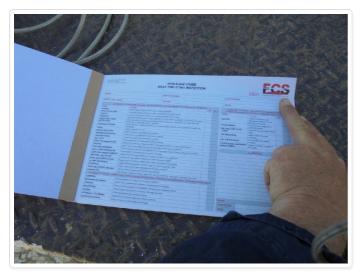
Hydraulic Reservoir & Oil Level	OK
Return Filters and Housing	OK
Suction Lines and Hoses	OK
Oil Cooler(s)	OK
Main Pump(s)	OK
Steering Pump	OK
Emergency Steering Pump	REMEDIED - Not functioning.
Steering Cylinder	OK
Relief Valves	OK
Flow Control Valves	OK
Pressure Filter and Housing	OK

NOT OK - Not functioning.

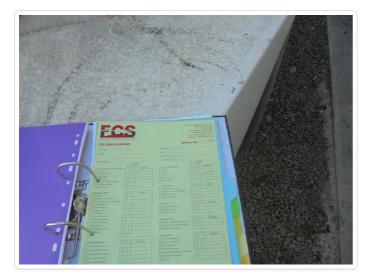
Compressor	OK
Air Reservoirs	OK
Drain Valves	OK
Air Lines	OK
Brake Chambers	REMEDIED - Front axle air leaking with park brake released.
Brake Valves	OK
Air Cylinders	OK
Gauges	OK
Air Dryer	OK

NOT OK - Front axle air leaking with park brake released.

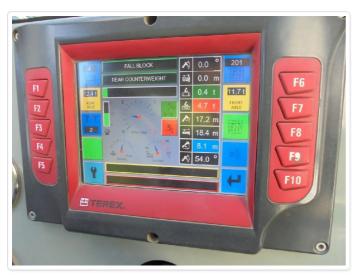
Rated Load - Boom Fully Extended - Load RCI

Rated Capacity Indicator	Measured
Radius, m	15.20	15.10
Load, kg	1,900.00	1,445.00

RCL and the RCI accuracy confirmed within acceptable tolerances. available test weights didn't exceed the lowest MRC. Accuracy of the RCL and load chart confirmed.
